AUTOCAR

Inspection powered by ANYLINE

Customer:	**John Doe**	Vehicle:	**Audi - Q4 e-tron (12992km)**
Identifier:	**125363789**	License Plate:	**ANYL1NE**
Inspection Date:	**03.04.25** at **09:09**	VIN:	**5GZCZ43D13S812719**

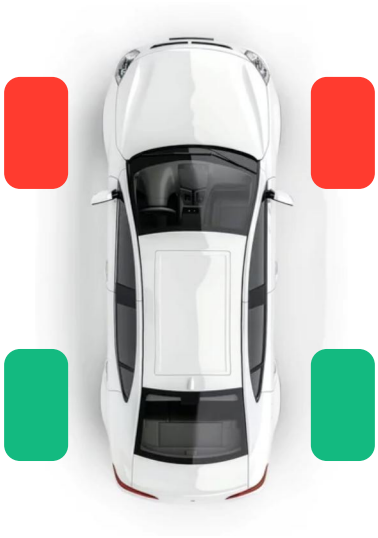
Left Front Tire

Replace Now (Tread ≤ 3.0mm)

3.1mm 1.6mm 3.1mm

Notes
- There is severe shoulder wear.
- Tire tread is less than recommended minimum.
- Use extreme caution in all conditions.

Right Front Tire

Notes
- There is severe outside wear.
- Tire tread is less than recommended minimum.
- Use extreme caution in all conditions.
